То:	Tom Blackman (Lockheed Martin)
Cc:	Steve McGee, Steve Ernst, Dan Sullivan, Katie Young, Cannon Silver, Michael Martin, Senda Ozkan
From:	Michael Byle
Date:	February 5, 2020
Subject:	Outfall Sealing East End of Blocks D and F

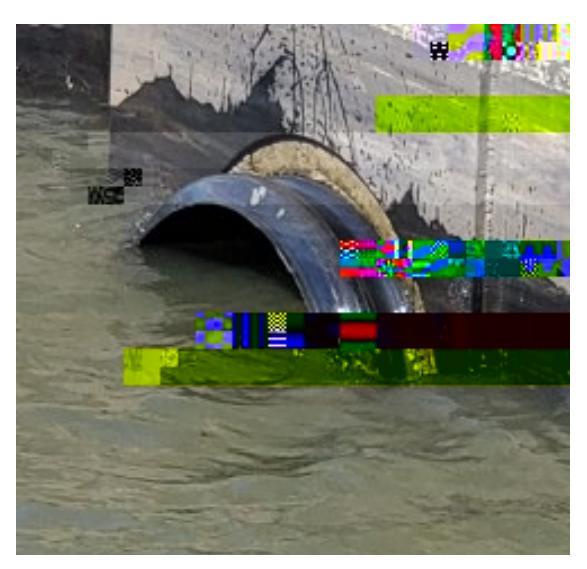
Observations of the outfall penetrations indicate that the concrete surrounding the corrugated HDPE pipe appears to be displaced and cracked. Probing in the cove adjacent these

Figure 1 - Recess in anular concrete at OF-00X

outlets indicates the presence of mounded granular soil that appears to be consistent with the volumes of material lost surrounding the culvert. Inspection of the inverts of the pipes is not possible, since they are partially submerged, but it appears likely that the conditions observed for the exposed portions are representative of the full circumference of the pipe.

Based on these observations, it appears that tidal action is flushing granular fill through openings around the circumference of the pipes at the two outfalls. The openings appear to be the result of fracturing and displacement of the concrete where it adjoins the steel wall components. Because the area over the pipes consists of concrete cast to the sloping granular fill surface, the concrete is in a trapezoidal shape and the granular fill loss is occurring in an hour-glass fashion concentrated along the contact between the granular fill and the concrete. This results in the surface expression appearing as a sinkhole several feet off the centerline of each pipe.
